Erosional patterns induced by coral reefs in the eastern coast of Brazil

Gerson FERNANDINO¹, Mauricio GONZÁLEZ², Verónica CÁNOVAS², Clemente Augusto Souza TANAJURA³ & Iracema Reimão SILVA⁴

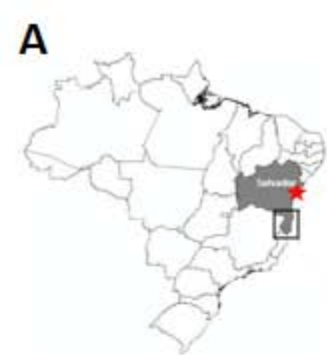
Figura 1. Localização e geologia da área de estudo. A) O detalhe (retângulo) mostra a localização da área de estudo em relação ao país e ao estado da Bahia. A estrela indica a localização da capital do estado da Bahia, Salvador; B) Detalhe da área de interesse (retângulo): costa norte do município de Porto Seguro, Bahia; e C) Detalhamento da geologia da área de estudo. Sedimentos neogênicos (Formação Barreiras) dominam a porção interna, enquanto sedimentos quaternários (recifes de coral, afloramentos de *beachrocks*, e depósitos lagunares) predominam ao longo da costa. Isóbatas demonstram formas irregulares, especialmente próximo aos recifes de coral e feições de fundo (fonte dos dados geológicos: Dominguez, 2000).
Figure 1. Location and geology setting of the study area. A) Detail (rectangle) shows the location of the study area in relation to Brazil and the state of Bahia. The star indicates the location of the capital of the state of Bahia, Salvador; B) Detail of the area of interest (rectangle): the northern coast of the municipality of Porto Seguro, Bahia; and C) Detail of the geology of the study area. Neogene sediments (Barreiras Formation) dominate the inland area while Quaternary sediments (coral reefs, beachrocks, beach and lagoon deposits) predominate along the coast. Isobaths show irregular shapes, especially near coral reefs and bottom features (geology data source: Dominguez, 2000).

The southern coast of the State of Bahia presents high geodiversity and is rich in coastal environments, such as coral reefs, mangrove forests and sandy beaches. Coral reef patches are found across the continental shelf adjacent to the studied shoreline, bordering the Coroa Vermelha, Ponta do Mutá and Ponta Grande tombolos, and the municipality of Porto Seguro (Fig. 1 and Fig. 2) (Leão & Kikuchi, 1999).

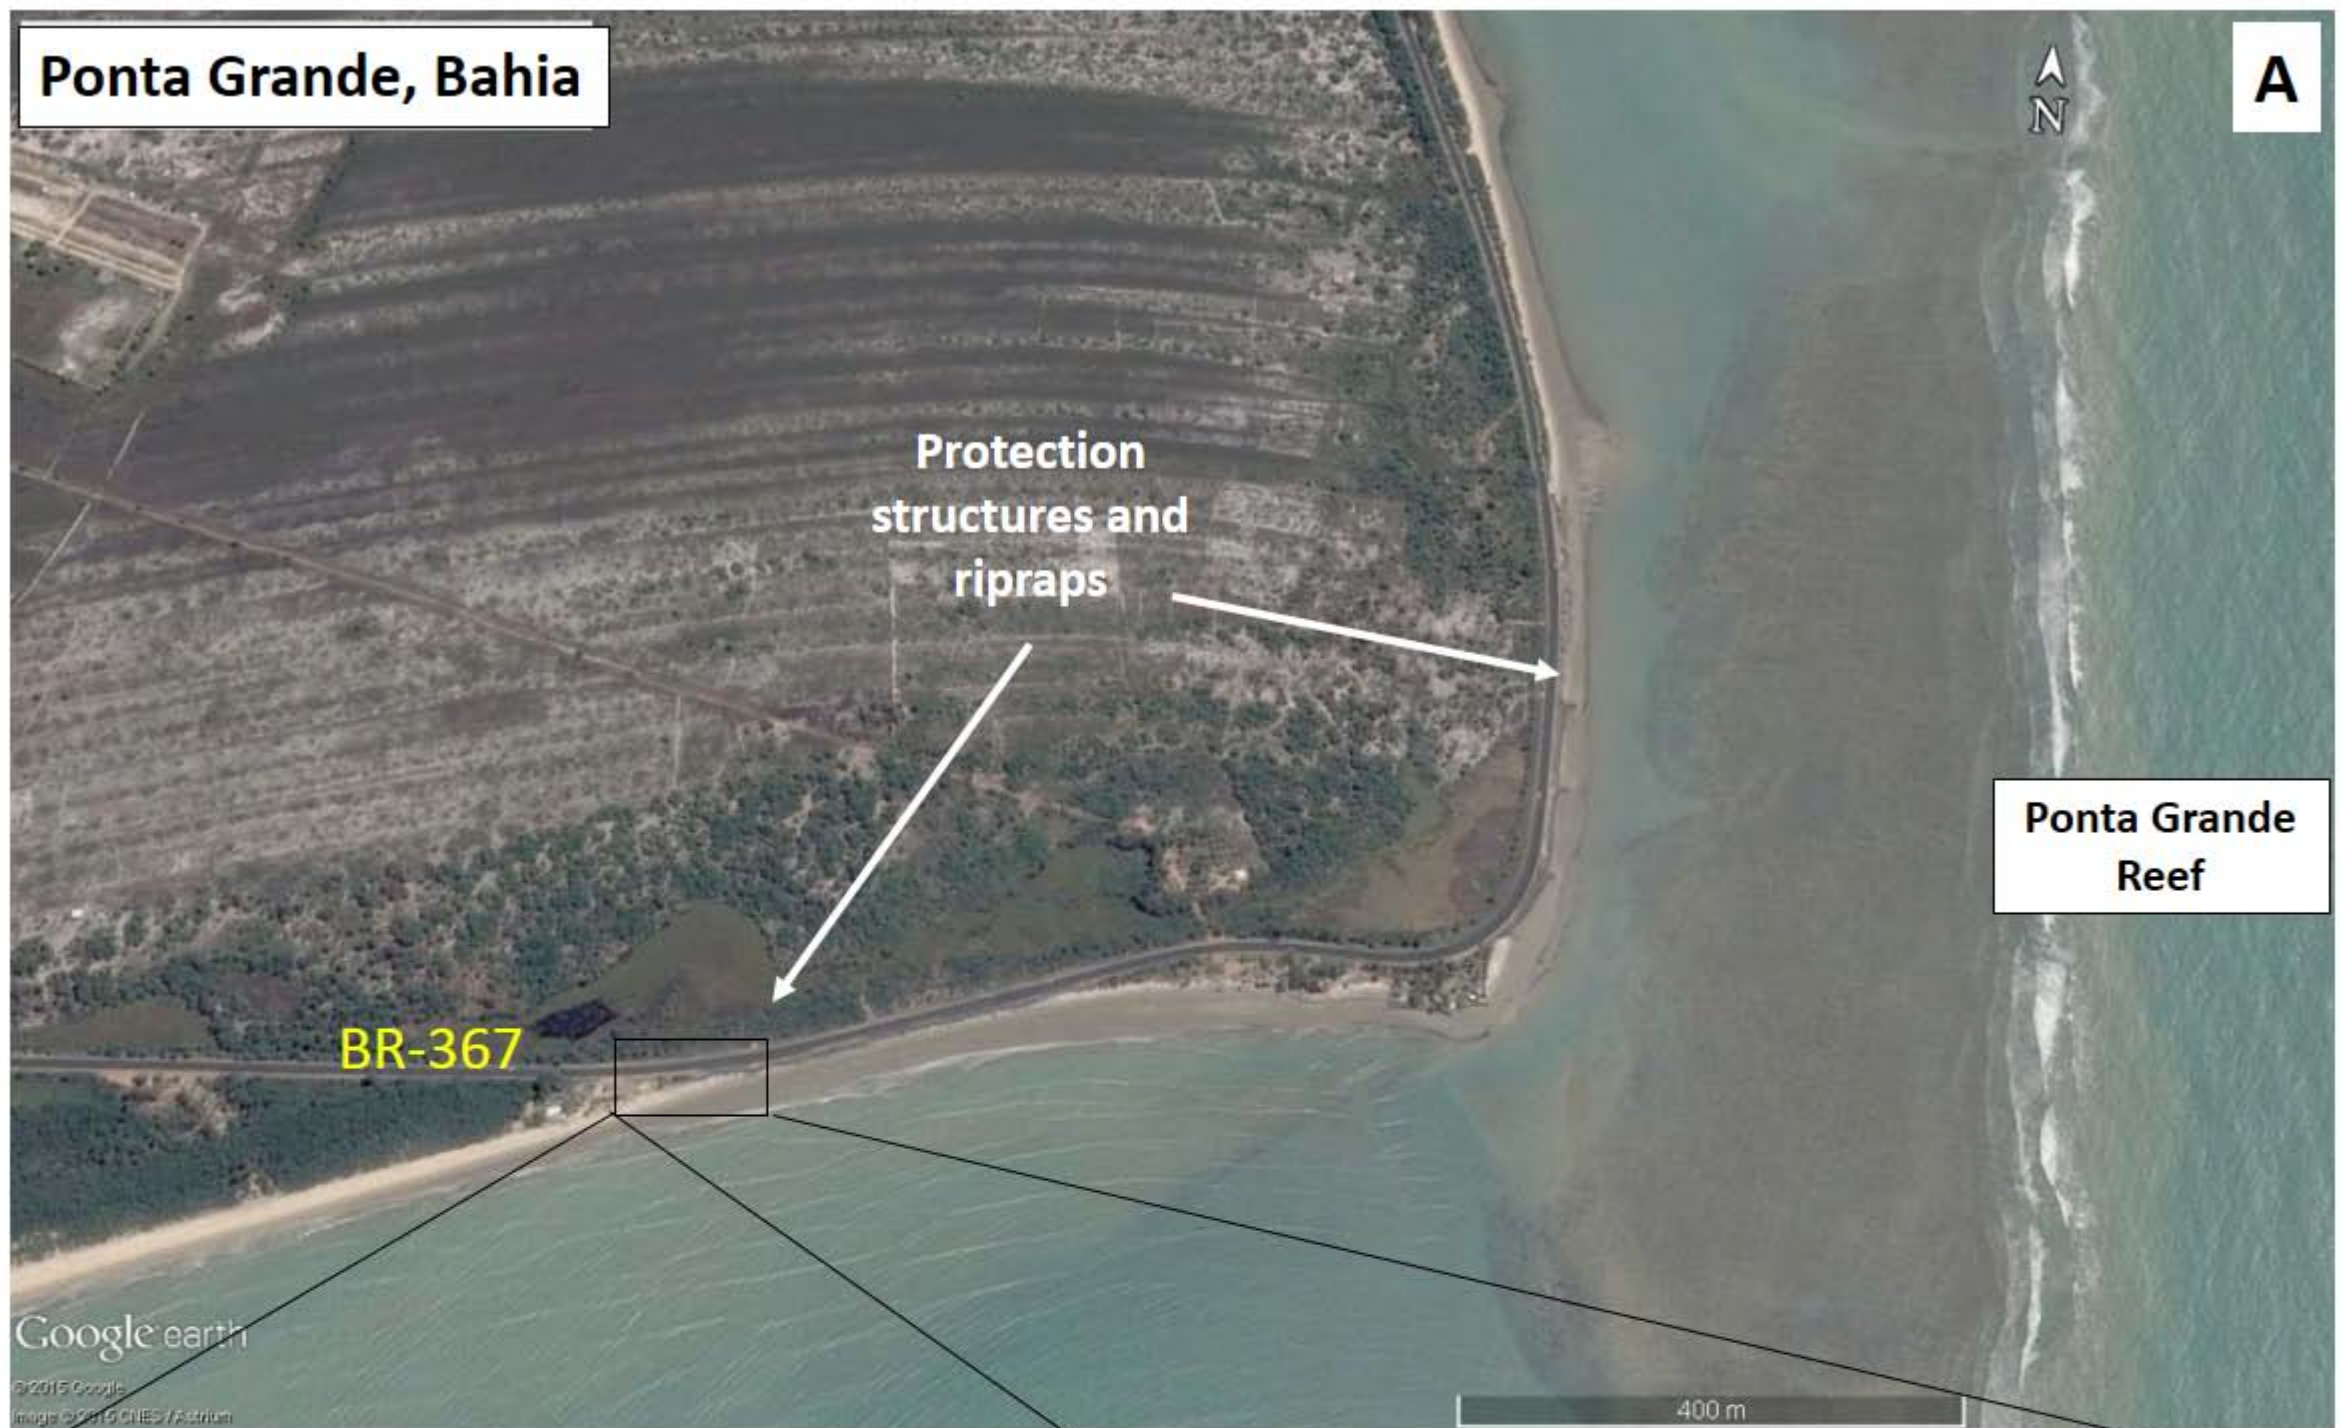
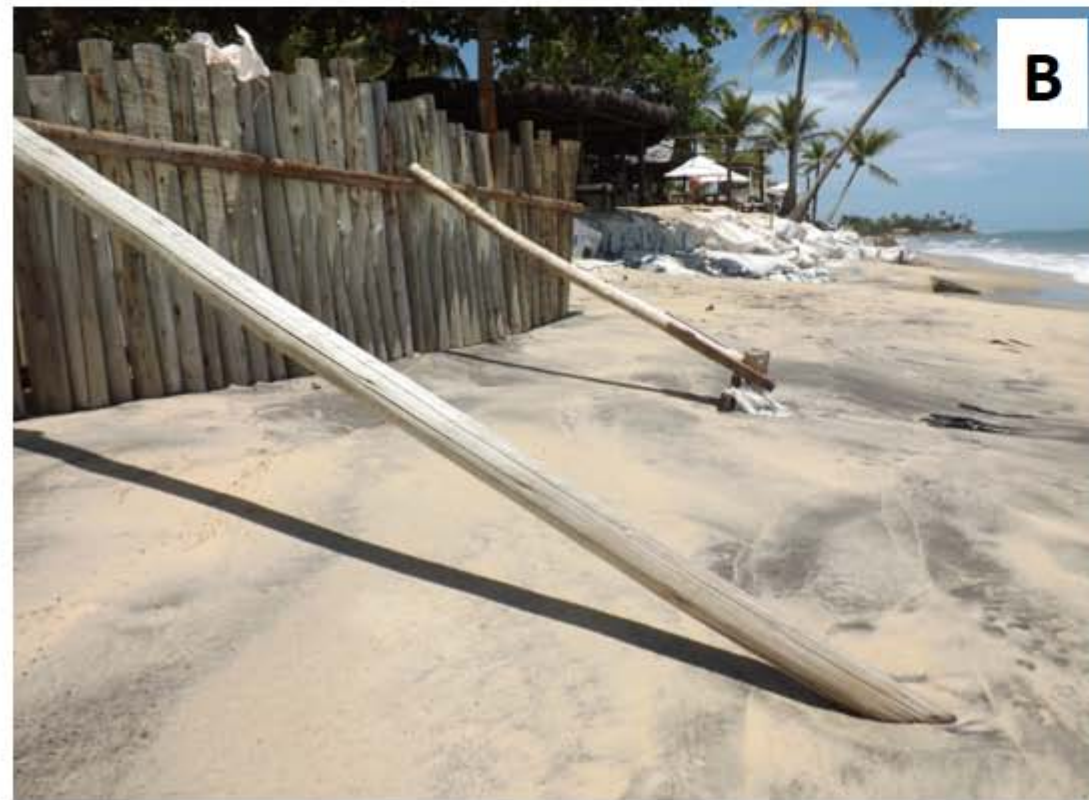
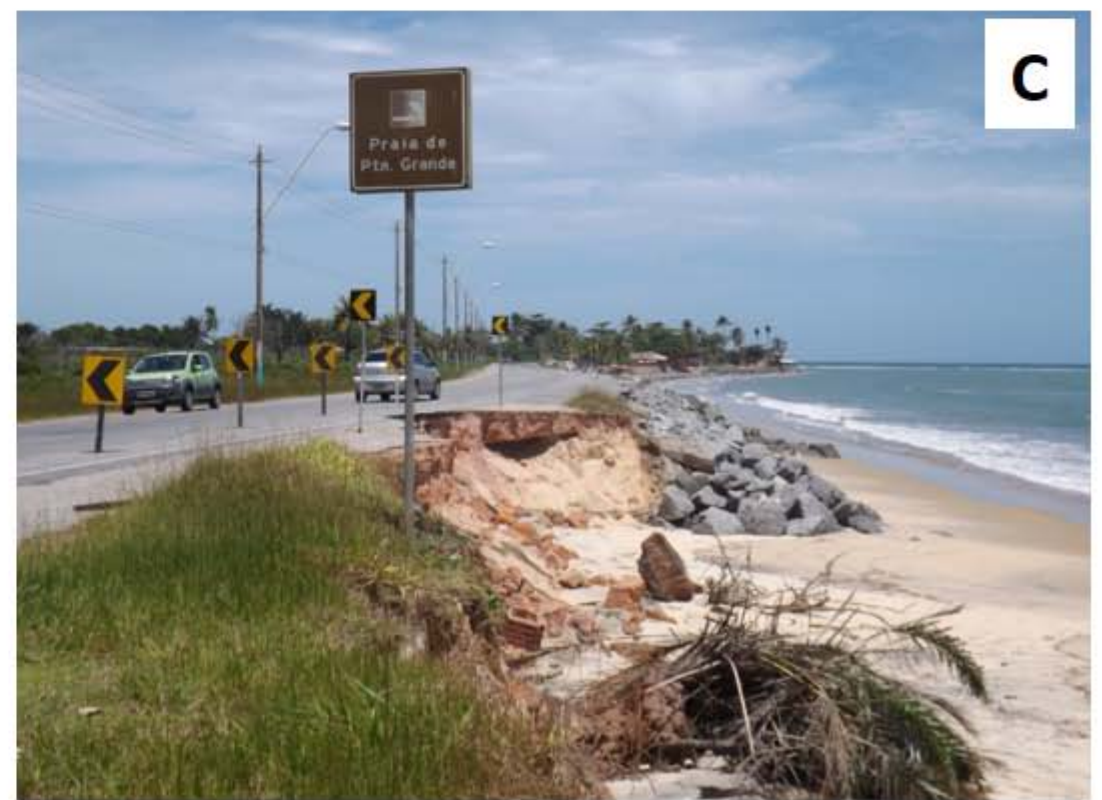
Ponta Grande, Bahia

Figura 3. Detalhe do tómbolo de Ponta Grande e danos causados pela erosão e medida tomadas para combater seus efeitos. A) Localização dos muros de proteção e enrocamentos construídos para tentar minimizar os efeitos da erosão costeira que afeta a rodovia BR-367 (setas) (Fonte: Google Earth); B) Exemplo de estruturas construídas para proteger propriedades privadas; e C)

Danos causados à rodovia BR-367 após uma tempestade em 2016. Note a presença de enrocamento (rochas) colocados anteriormente como medida de proteção contra erosão.

Figure 3. Detail of the Ponta Grande tombolo and damages caused by coastal erosion and actions taken to minimize its effects. A) Location of shoreline protection walls and ripraps built in order to try to minimize the effects of the coastal erosion that affects the BR-367 road (arrows) (Source: Google Earth). B) Examples of structures built to protect a private property; and C) Damage to the BR-367 road after a storm in 2016. Note the presence of a riprap (rocks) previously placed as a protective measure against erosion.

One of the most severe (and recurrent) erosive hotspots of the study area is located near the border between sectors 2 and 3. The BR-367 road, which belongs to the national highway network, is the only communication between the center of the municipality of Porto Seguro and the districts located along the Ponta Grande tombolo. In this area, the road approaches the shoreline and is constantly damaged by the erosion of the adjacent beach (Ponta Grande beach), especially during austral autumn/winter months (Mar-Apr-May/Jun-Jul-Aug), when more energetic waves from the southeastern quadrant reach the coast (Martin *et al.*, 1998; Bittencourt *et al.*, 2000) (Fig. 3). Thus, a riprap was built to protect this road. However, this structure proved to be clearly inefficient in protecting the shoreline. Evidence of the high periodicity of these erosive events can be easily obtained through reports from the local media showing the damages to the road. The most recent event was reported on 15 May 2017. Consequently, there is no longer a recreational beach in the area, especially during high water conditions. In addition, the presence of the riprap itself and rocks that collapsed from this structure hamper the access to the beach, thus diminishing its recreational appeal.

Apart from a riprap built near the road, protective structures are scarce, except in some private properties where walls were built using either concrete or wood. Sand bags were also placed in an attempt to interrupt or minimize erosive effects (see Fig. 3).
